EASTBLUFF	Inspected by:	Inspected November 2008
------------------	---------------	-------------------------

EVALUATION NOTES

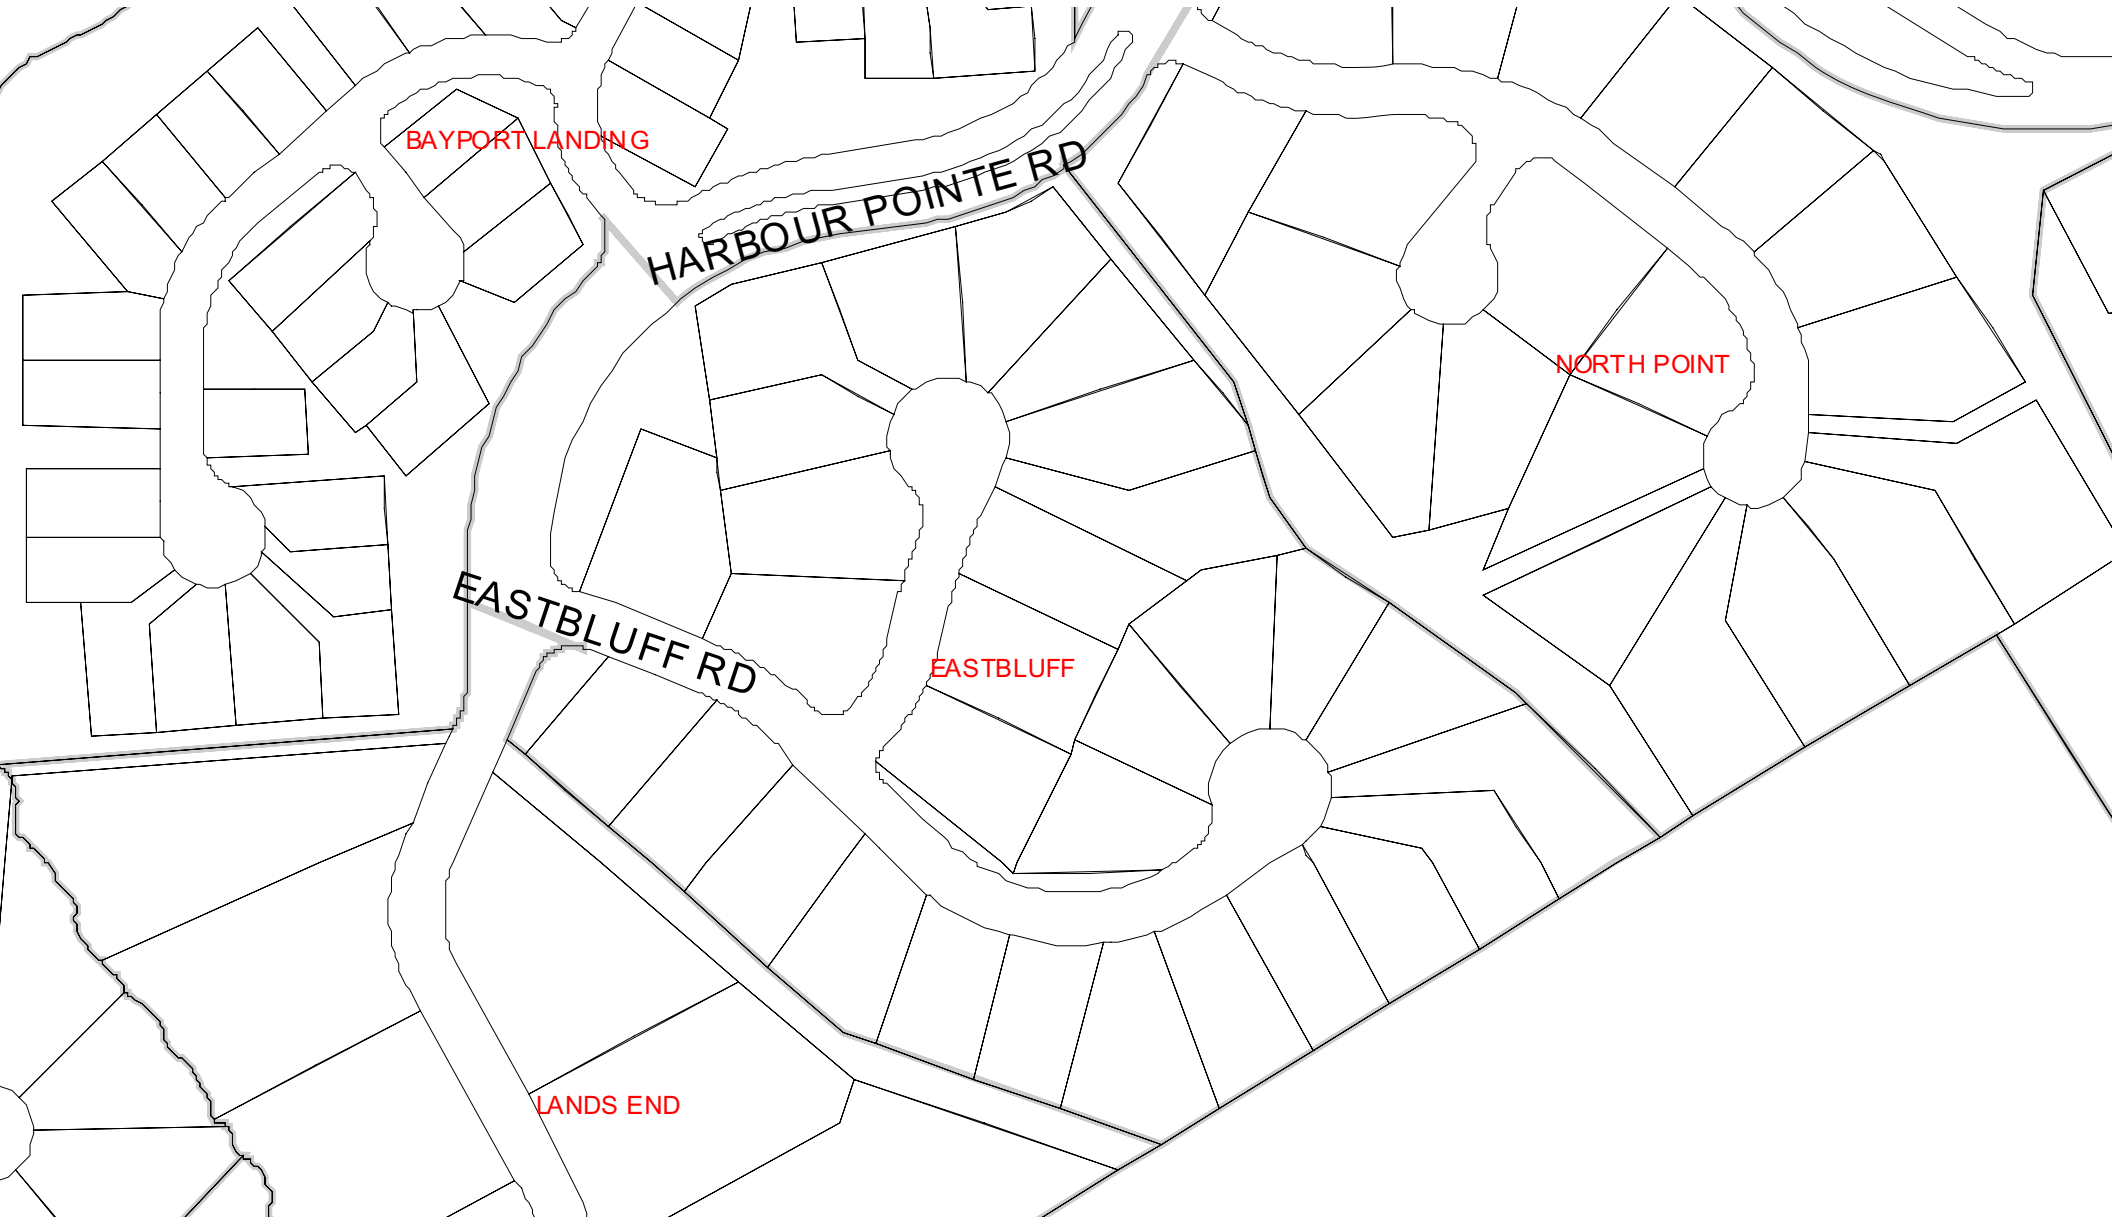
EASTBLUFF RD

EASTBLUFF

3858 - Extensive alligating at intersection. Cracking between 14004 and 13919 as well as around utility covers.

3859 - Extensive cracking in cul-de-sac, alligating at 5911,5908,5903.
